# An Analysis of Arsenic Replacement Wells to Determine Validity of Current Department of Natural Resources Guidance

Title: An Analysis of Arsenic Replacement Wells to Determine Validity of Current Department of Natural Resources Guidance

Investigators: Kelley O'Connor, WDNR, Northeast Region, Green Bay

Project ID: 156

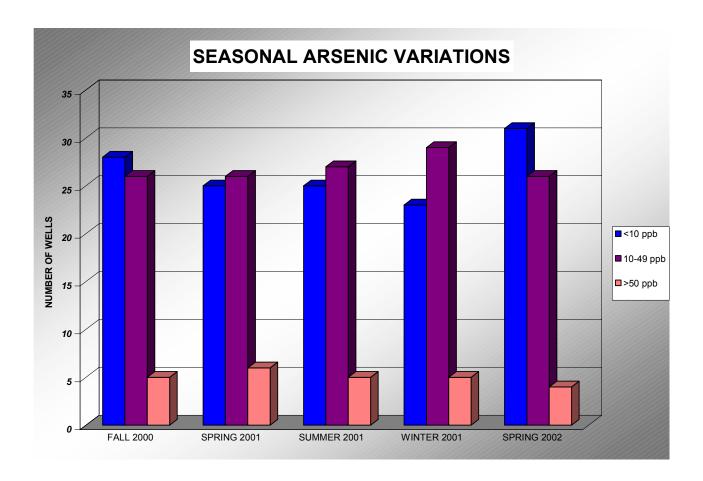
Figure 3: Seasonal Variations of Arsenic Levels

Figure 3 illustrates the range of arsenic in the wells during each of the sampling events. Some wells that participated in the earlier Weissbach *et al* (1998) study were not sampled during Spring, Summer and Winter of 2001; these were dropped from this study because there were not any significant changes

in the arsenic level over time nor had there been any seasonal variation in these wells during the earlier study. This accounts for the larger number of wells in the <10 ppb category during the Fall of 2000 and the Spring of 2002 sampling events.
